Dynamic Load Environment of Bridge Mounted Sign Support Structures

by Arthur Huckelbridge, Ph.D., Case Western Reserve University

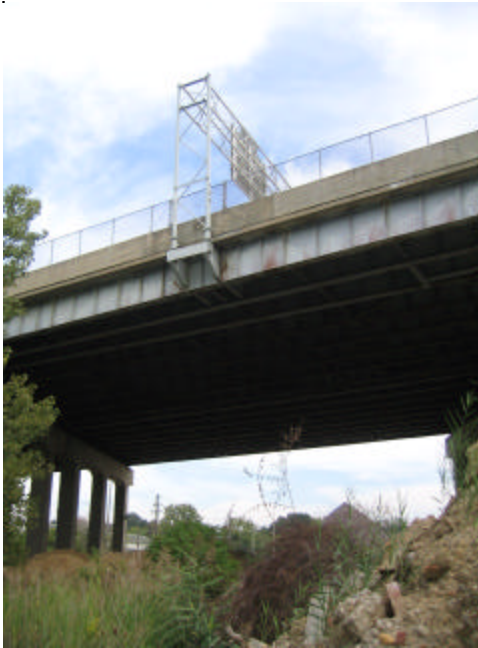
This special student study at CWRU was initiated to investigate the fatigue failure of a bridge-mounted, welded aluminum truss sign support. This sign support is located in ODOT District 12, on interstate route 77 just south of Cleveland, on bridge no. CUY-77-0952 over the Cuyahoga river valley (see photo). One of the upper chord members of this truss fractured completely due to the development and growth of a fatigue crack at the welded joint connecting it to the end web diagonal. The sign support had been in service roughly 30 years. As the failure represented a potential safety issue for the traveling public, it was decided to try to determine the cause of the failure, in order to bring to light any concerns for other such structures throughout the state.

The bridge consists of 25 spans, with a total length of 3,023 ft. The sign support is located near the midspan point of the 5th span from the south end of the bridge; the length of this span is approximately 128 ft. The sign support truss itself has a span of approximately 73 ft, over the southbound lanes.

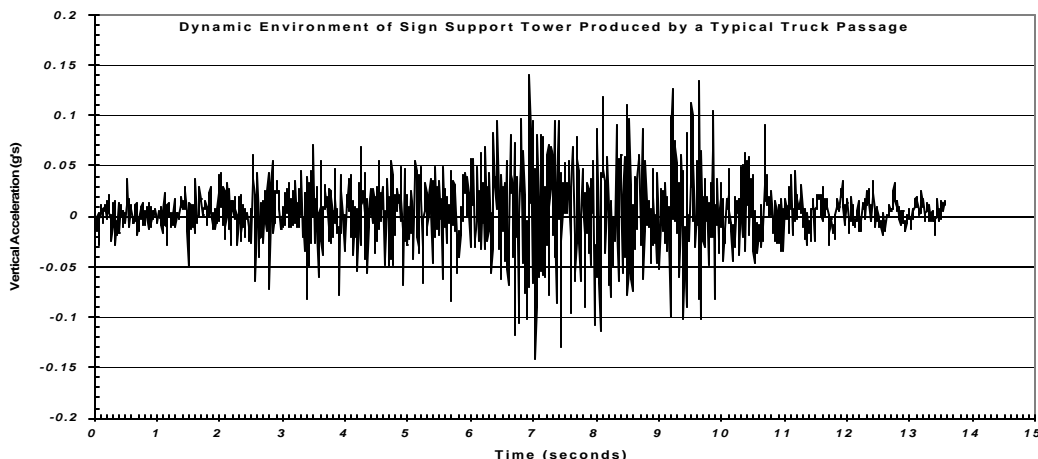
(an ODOT dumptruck, loaded with gravel to a gross weight of roughly 55,000 lbs, and traveling at approximately 50 mph). A typical vertical acceleration trace measured on the support tower is shown in the plot below.

One of the surprising features of the bridge vibration record was its length. Significant vibrations lasted nearly 15 seconds, even though the time that the truck was actually on the span containing the sign support truss was less than 2 seconds. Obviously, due to considerable structural continuity over the piers, vibrations began while the truck was still several spans away from the span containing the sign, and continued until the truck was several spans past the span containing the sign.

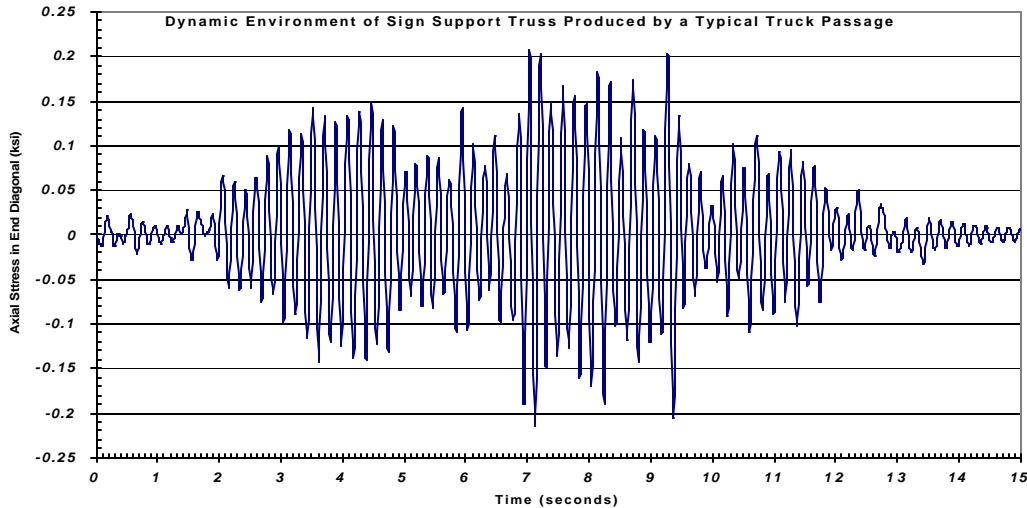
The stress history of an end web diagonal, as computed by a finite element program and utilizing the measured truck-induced acceleration record above as input, is shown in the graph below. The sign truss vibration takes place primarily at the natural vibration frequency of the sign truss, which is approximately 5 Hz. In the 15 second response record produced by a single truck passage, roughly 82 cycles of sign support response take place.

The equivalent constant amplitude RMC stress range, for the variable amplitude trace shown above, is approximately .20 ksi, which is well below the AASHTO constant amplitude fatigue limit (CAFL) of .44 ksi for this weld detail (category ET). One should keep in mind, however, that the AASHTO CAFL is intended to provide a fatigue lifetime of roughly 20,000,000 cycles, which is generally considered adequate for wind induced vibrations. If one extends the category ET S-N curve beyond the CAFL, the expected fatigue lifetime for a stress range of only .20 ksi would be approximately 225,000,000 truck passage cycles, as shown in the plot below. The fatigue lifetime of 225,000,000 cycles, at roughly 82 response cycles per truck passage, would correspond to an expected fatigue lifetime of approximately 2,700,000 truck passages.

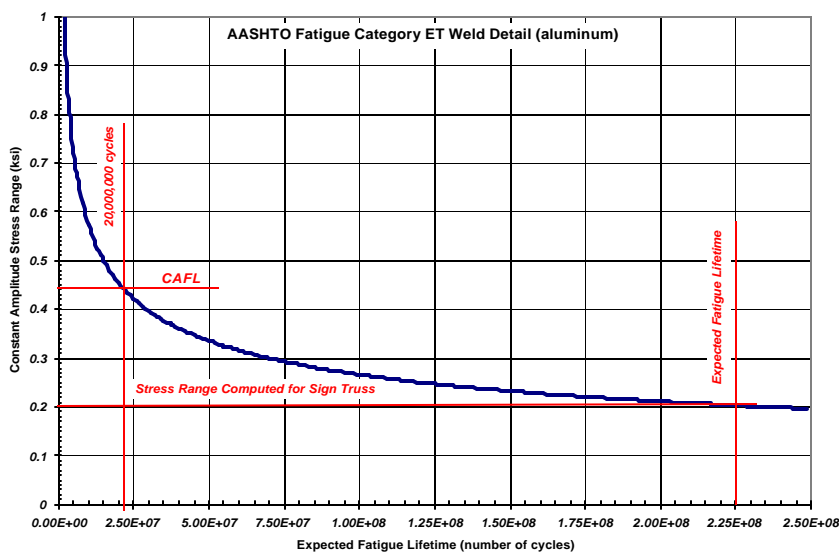
On a busy interstate route such as I-77, 2,700,000 truck passages can certainly take place in less time than the expected lifetime of the bridge itself. At a rate of 200 truck passages per day, for example, the expected lifetime would be roughly 37 years, which is only slightly above the age of the sign truss at the time of its failure.

These preliminary findings would seem to indicate that there is cause to look carefully at bridge-mounted sign support structures for fatigue issues. Of particular concern would be longer structures, where vehicles are on the bridge for a long enough period of time for the sign structure to accumulate a considerable number of response cycles.
