APPENDIX B

Description of Distresses in Composite Pavements

**[Composite Pavements have rigid bases (concrete or brick)
and asphaltic surfaces]**

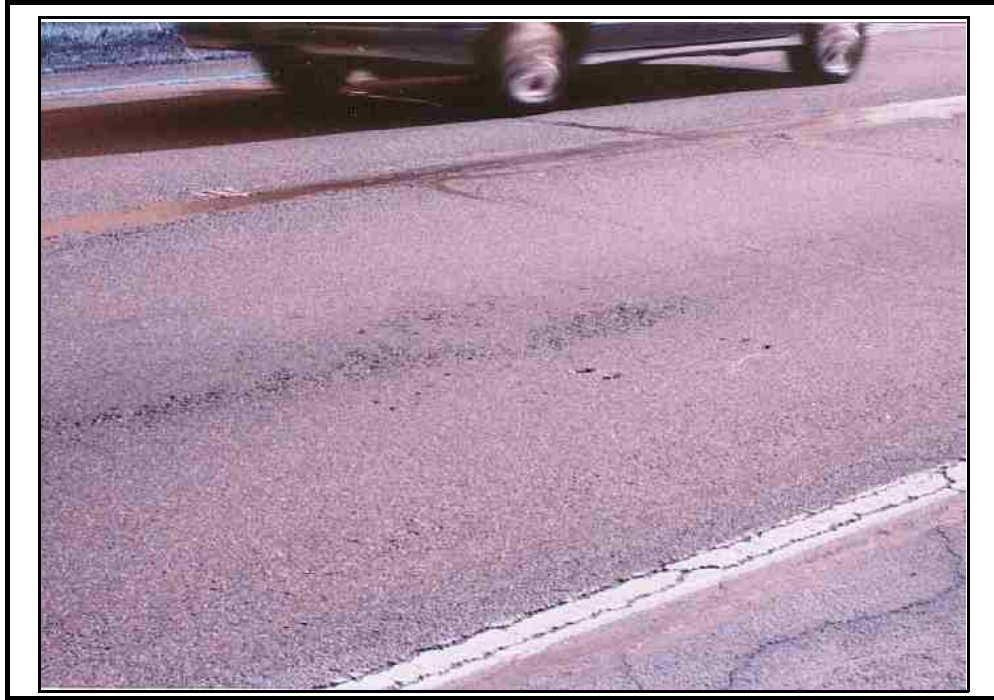
Photo B-1. Raveling in Composite Pavement, Medium Severity

Distress Type:	Raveling
Description:	Disintegration of the pavement from the surface downward due to the loss of aggregate particles. Raveling may occur as a result of asphalt binder aging, poor mixture quality segregation, or insufficient compaction.
Severity Level:	Low-- very little coarse aggregate has worn away. Loss of fine aggregate. Coarse aggregate exposed. Medium-- surface has an open texture and is moderately rough with considerable loss of fine aggregate and some coarse aggregate removed. High-- most of the surface aggregate has worn away or become dislodged. Surface is severely rough and pitted and may be completely removed in places.
Extent Level:	Occasional-- less than 20 percent of the surface area is raveling. Frequent-- between 20 and 50 percent of the surface area is raveling. Extensive-- more than 50 percent of the surface area is raveling.

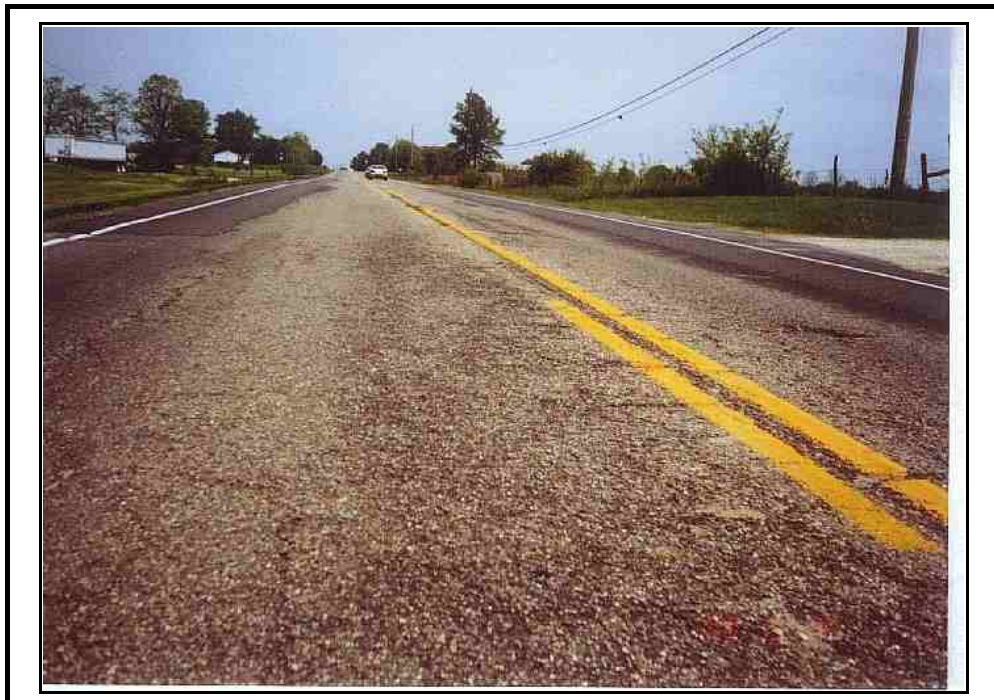
Photo B-2. Raveling in Composite Pavement, High Severity

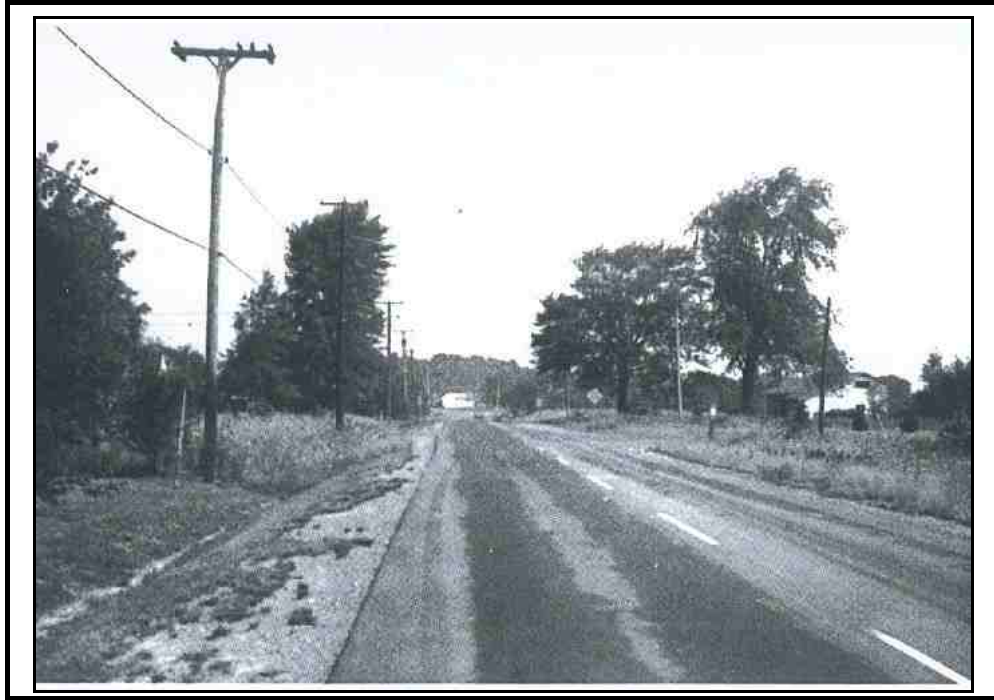
Photo B-3. Bleeding, High Severity

Distress Type:	Bleeding
Description:	Bleeding or flushing is the presence of free asphalt binder on the pavement surface. Bleeding is caused by an excess amount of bituminous binder in the mixture and/or low air void content.
Severity Level:	Only 2 severity levels are defined. Medium-- both coarse aggregate and free bitumen are noticeable at the pavement surface. High-- surface appears black with very little aggregate noticeable.
Extent Level:	Occasional-- less than 10 percent of the length exhibits bleeding. Frequent-- between 10 and 30 percent of the length is bleeding. Extensive-- bleeding occurs in more than 30 percent of the length.

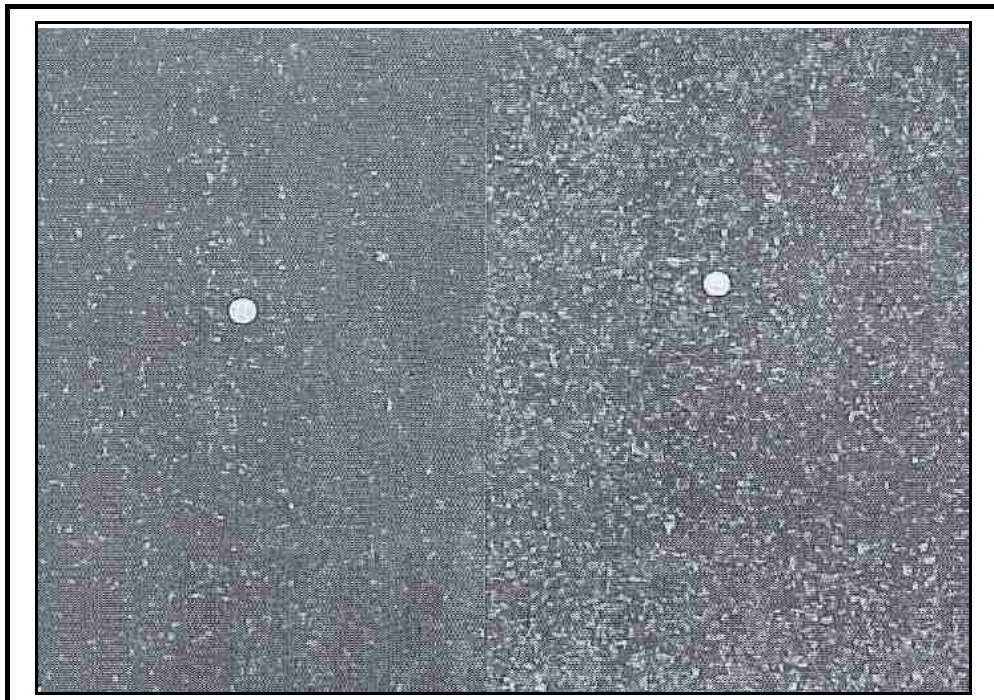
Photo B-4. Close-up view of Bleeding, High and Medium Severity
High Severity on left shows most aggregates covered with asphalt and Medium Severity
on right shows less aggregates covered with asphalt

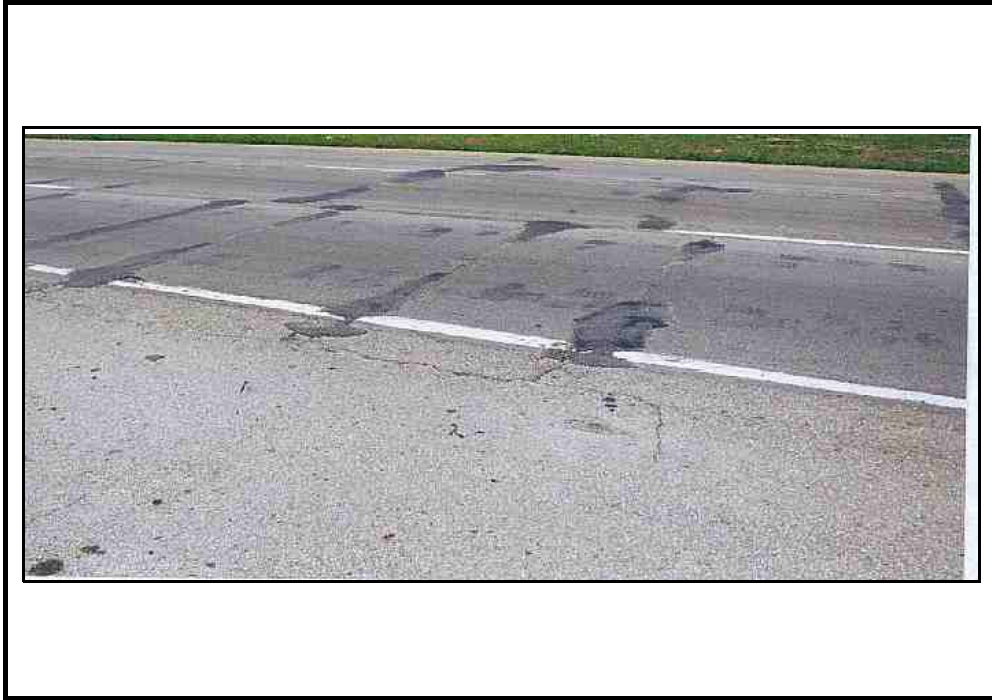
Photo B-5. Patching in Composite Pavement, Medium Severity

Description: Patching is either the placing of asphalt concrete on the surface of the existing pavement or the replacement of the existing pavement in small isolated areas.

Severity Level: Low-- patch size < 0.1 m² (1 sq. ft.).

Medium-- patch size < 0.8 m² (1 sq. yd.).

High-- patch size > 0.8 m² (1 sq. yd.).

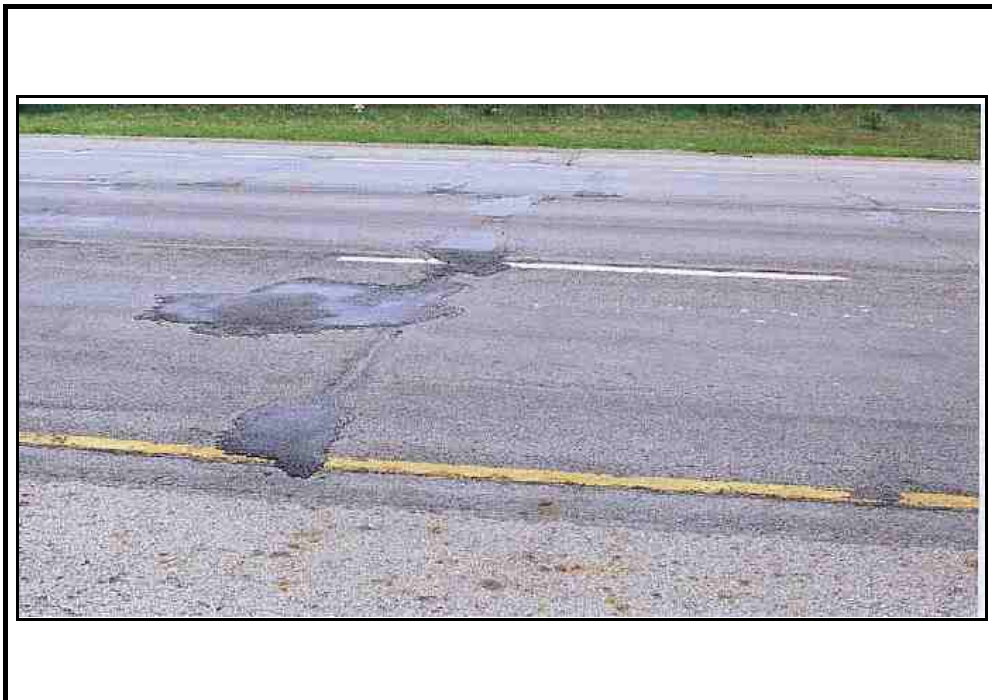
Photo B-6. Patching in Composite Pavement, High Severity

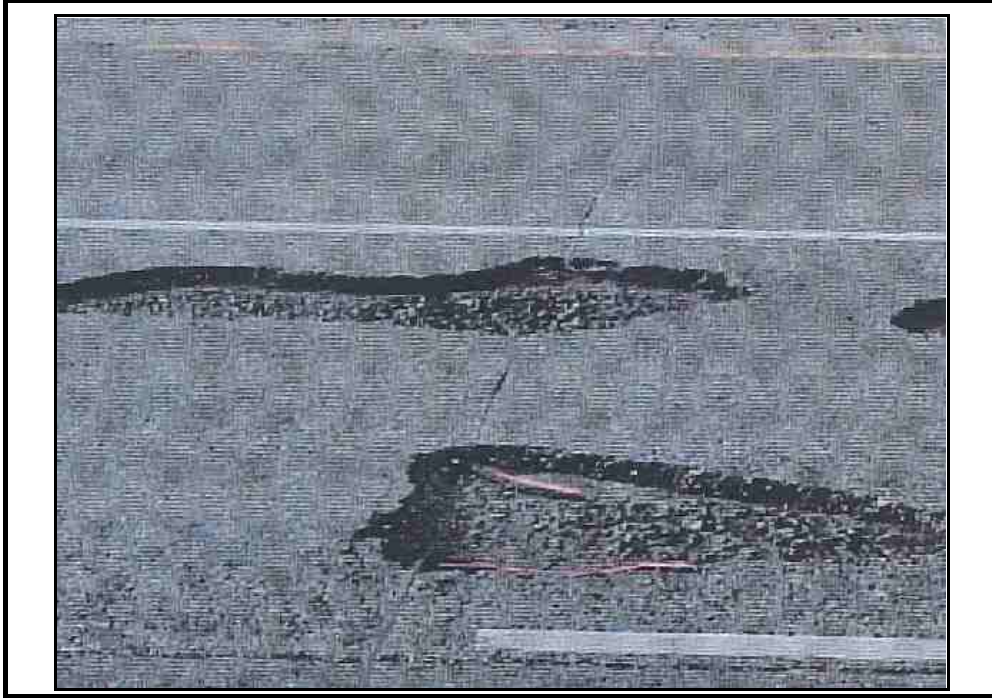
Photo B-7. Surface Disintegration in Composite Pavement

Description: Loss of surface by debonding is the removal of the asphaltic surface layer from the underlying layer. The problem is most common with thin asphalt surface layers [less than 50 mm (2 inches)] and is caused by freeze-thaw action or poor bonding of the two layers during construction.

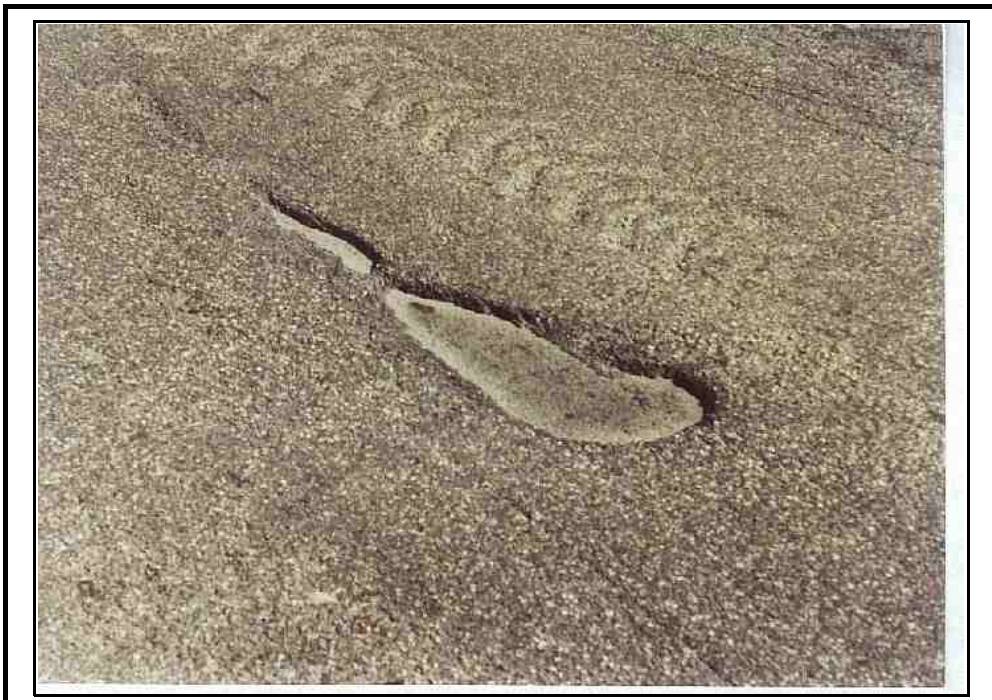
Photo B-8. Debonding in Composite Pavement, Medium Severity

Depth of Debonded Area	Debonded Area <0.8 m² (1 sq. yd.)	Debonded Area >0.8 m² (1 sq. yd.)
< 25 mm (1")	Low	Medium
> 25 mm (1")	Medium	High

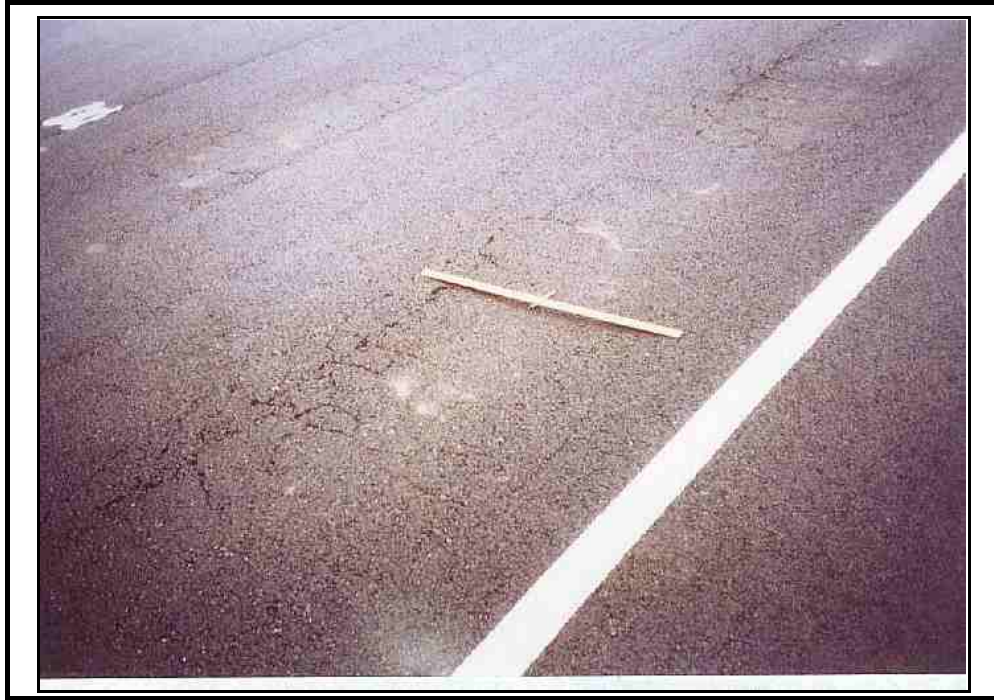
Photo B-9. Rutting, Medium Severity

Description: Ruts are vertical deformations in the pavement surface along the wheel tracks. In severe cases pavement uplift may occur along the sides of the rut, but in most instances only a depression is noticeable. Rutting is caused by consolidation or lateral movement of any or all pavement layers, including subgrade, under traffic.

Medium-- readily noticeable, depth more than 6 mm (1/4 inch), less than 25 mm (1 inch).

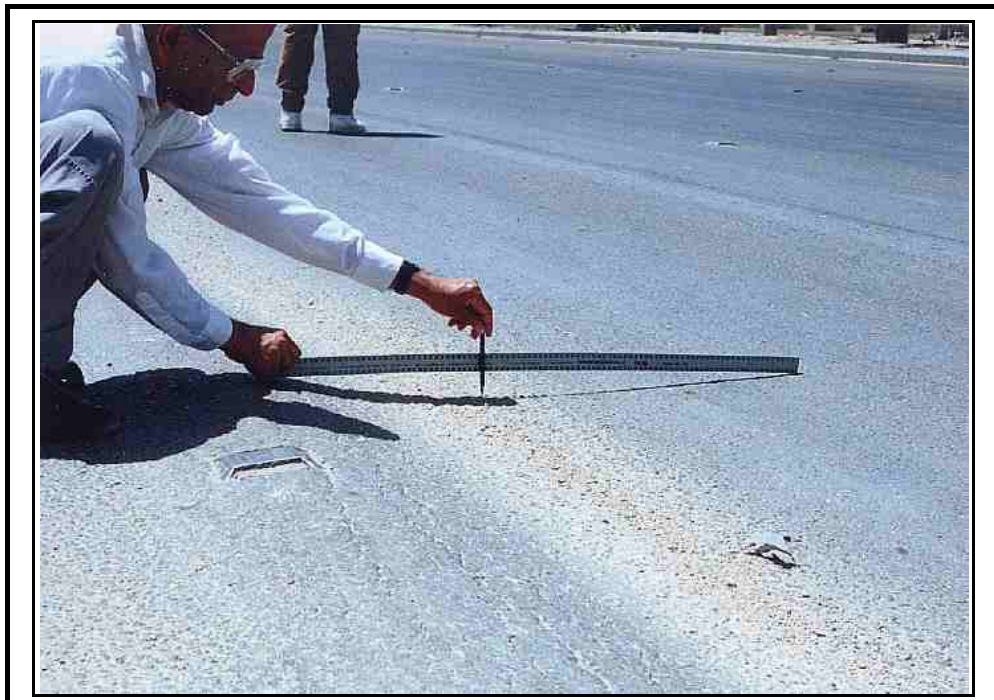
Photo B-10. Rutting, High Severity

High-- definite effect upon vehicle control, depth greater than 25 mm (1 inch).

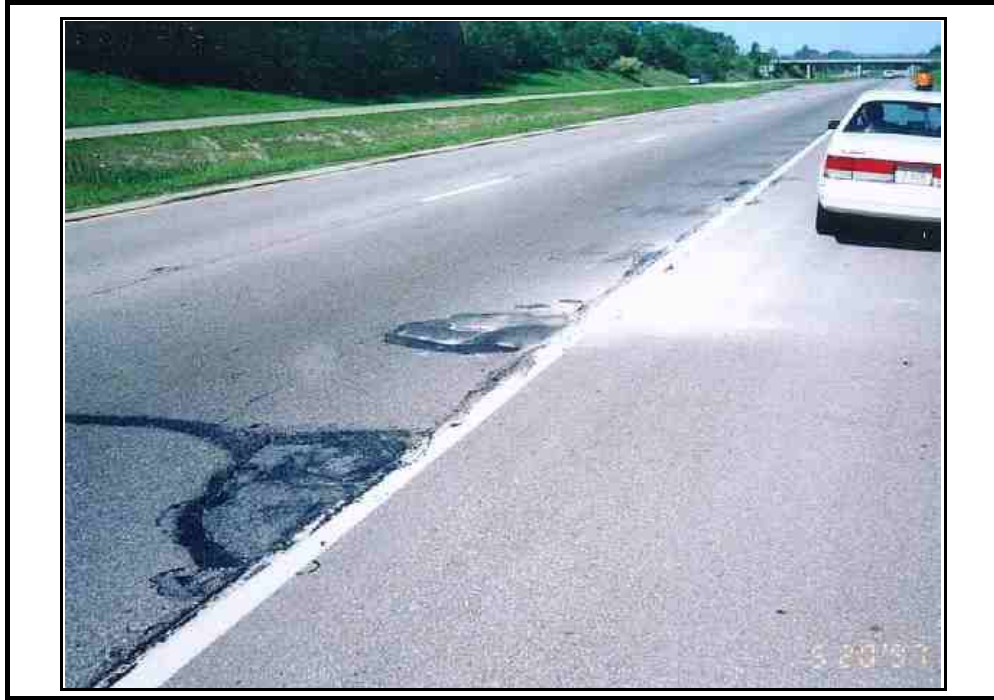
Photo B-11. Pumping in Composite Pavement, Medium Severity

Description: Pumping is the ejection of fine soil particles through pavement cracks, joints, or along pavement edges. Pumping can be identified by the presence of surface staining and base or subgrade material near joints or cracks. Shoulder disintegration at the pavement edge is often an indicator of pumping beneath the slab.

L & M-- Some staining of the surface around cracks or joints is noted. Rater is quite certain that pumping exists.

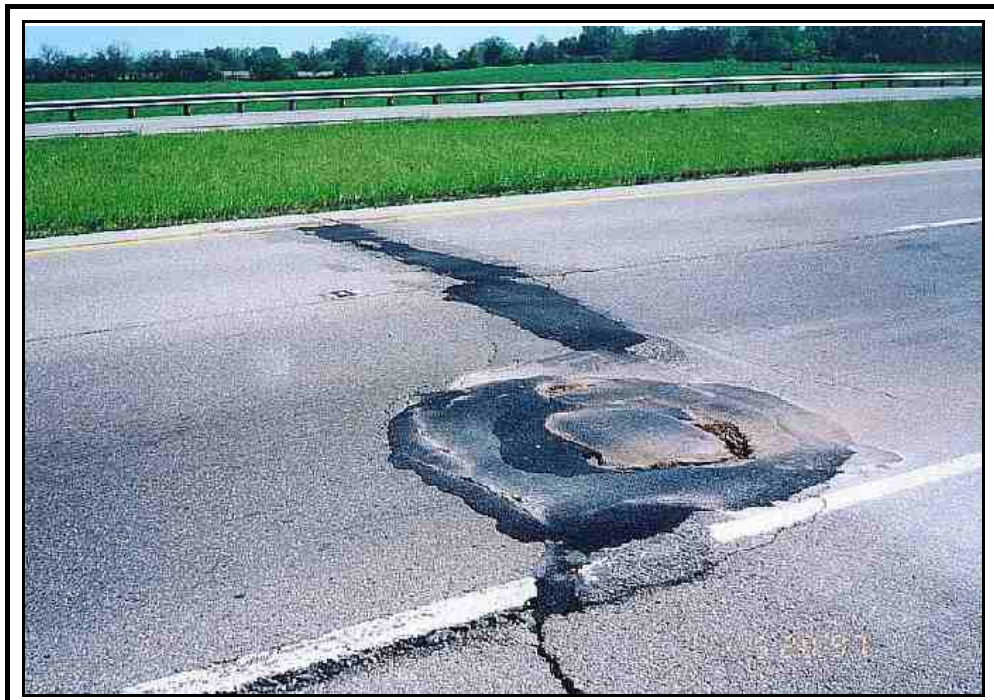
Photo B-12. Pumping in Composite Pavement, High Severity

High-- Clear evidence that pumping exists. Excessive staining, medium severity or greater, faulting, corner breaks or punchouts. Rater is quite certain that pumping exists.

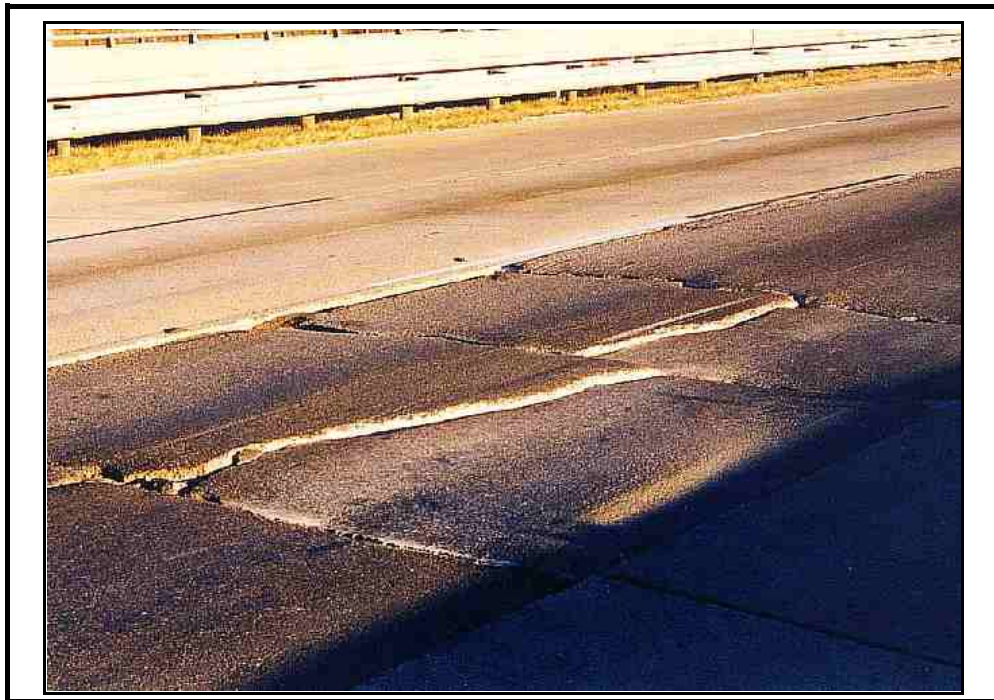
Photo B-13. Shattered Slab of Composite Pavement, High Severity

Description: Shattered slab is the breakup of the underlying rigid base made evident by surface reflection cracking and/or distortion. Reflection cracks in the asphaltic layer forming rectangular areas less than 1.5 m by 1.5 m (5 ft. by 5 ft.) may indicate that the underlying slab is broken up. Diagonal reflection cracks at transverse joints are indicative of corner breaks in the rigid base. Progressive deterioration will include distortion and faulting of the shattered area. This distress is caused by poor base support or fatigue of the concrete layer.

High-- severe distortion and poor ride quality over the shattered area. Crack pattern indicates break up of the slab into small pieces [less than 0.8 m² (1 yd²)].

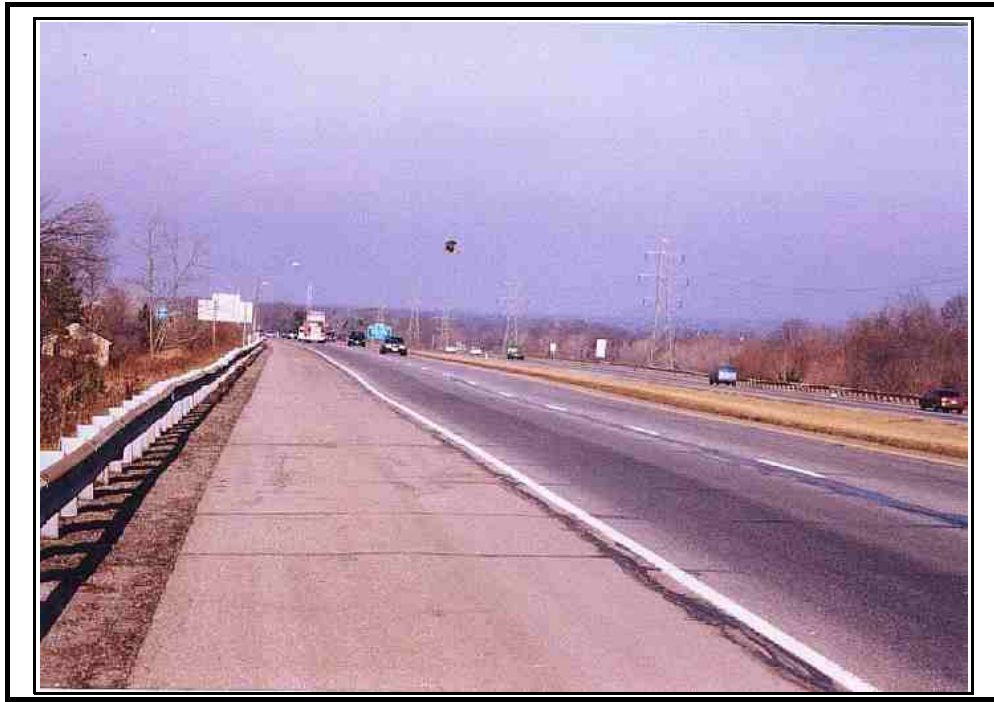
Photo B-14. Settlement in Composite Pavement, Medium Severity

Description: Settlement is a dip in the longitudinal profile of the pavement surface. Settlement shall be considered a distress when it causes a noticeable effect upon riding quality. Settlement should not be confused with corrugation, which is another type of surface profile deficiency.

Medium-- some discomfort to passengers, driver able to maintain control with slight corrective action.

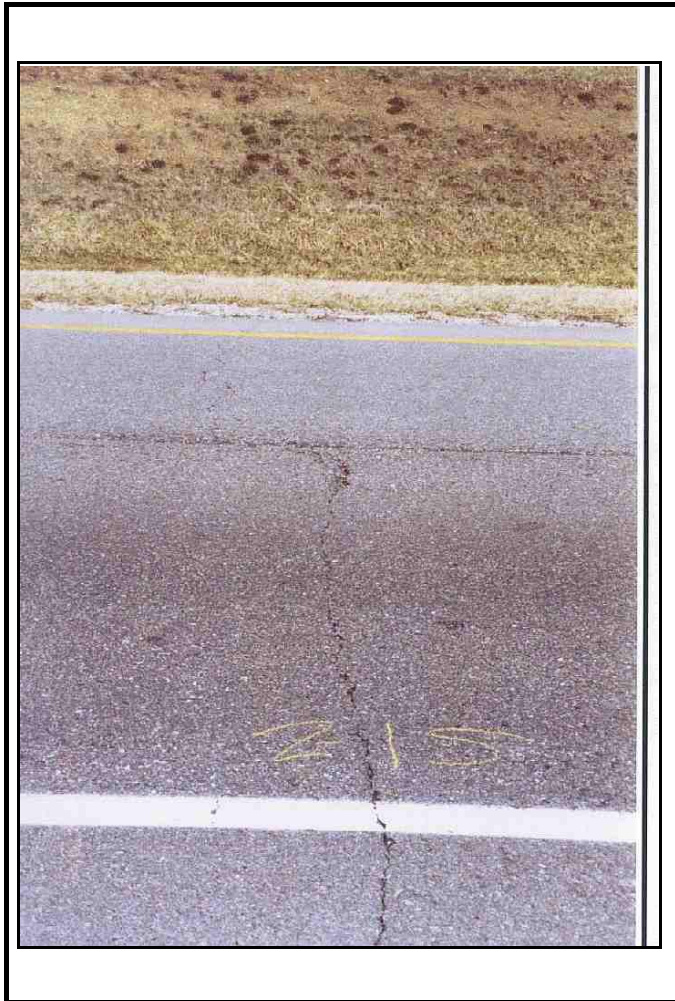
Photo B-15. Unjointed Base, Transverse Cracking in Composite Pavement, Low Severity

Description: A crack or break at approximately right angles to the pavement centerline. For composite pavements where the rigid base layer does not have transverse joints (CRC pavements for instance) all transverse cracking is evaluated regardless of location. For jointed bases, a separate evaluation is made of reflective cracks at 1) the joints; and 2) other (non-joint) transverse cracking. Usually all underlying base cracks and joints are eventually reflected through the flexible surface. Additional transverse surface cracking may result from thermal shrinkage and age hardening of the asphaltic layer.

Low-- crack width less than 6 mm (1/4 inch) with no spalling or distortion along crack edges.

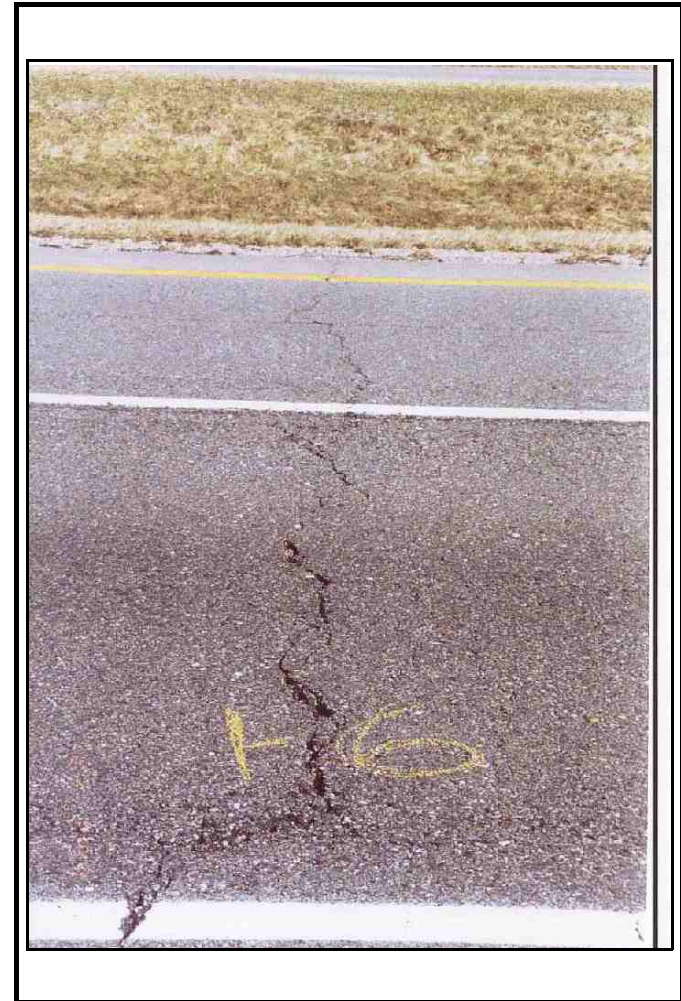
Photo B-16. Unjointed Base, Transverse Cracking in Composite Pavement, High Severity

High-- crack opened or spalled to a width greater than 25 mm (1 inch) over at least one half its length.

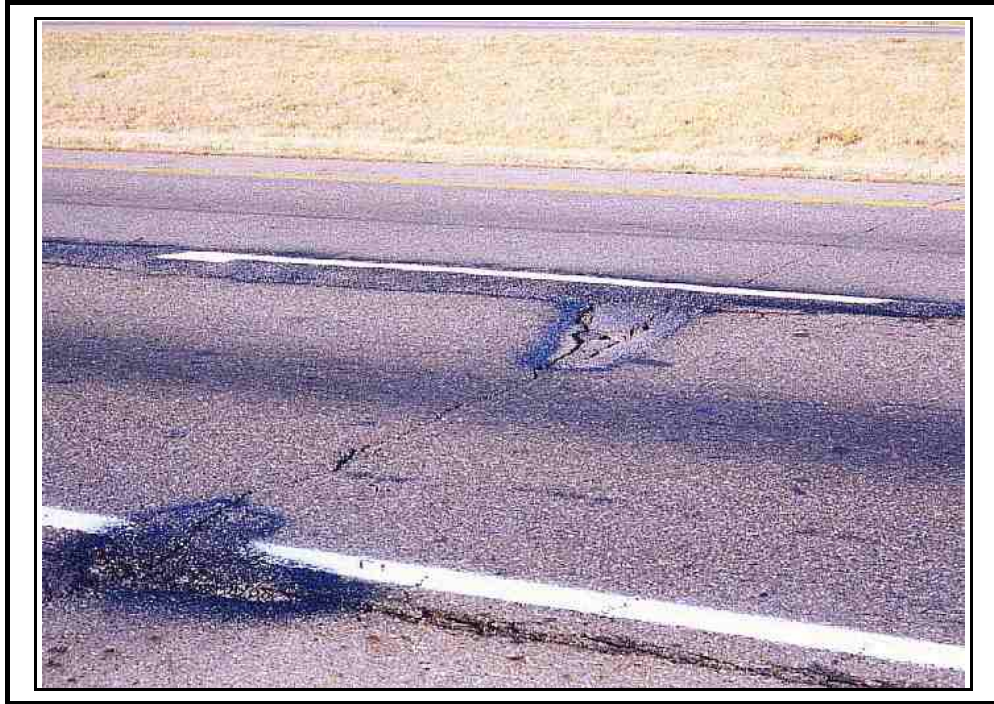
Photo B- 17. Jointed Base, Reflection Cracking in Composite Pavement, Medium Severity

Extent is based upon the estimated percentage of transverse joint length which has reflected through the asphalt surface. Except for new pavements or overlays the extent will likely be extensive.

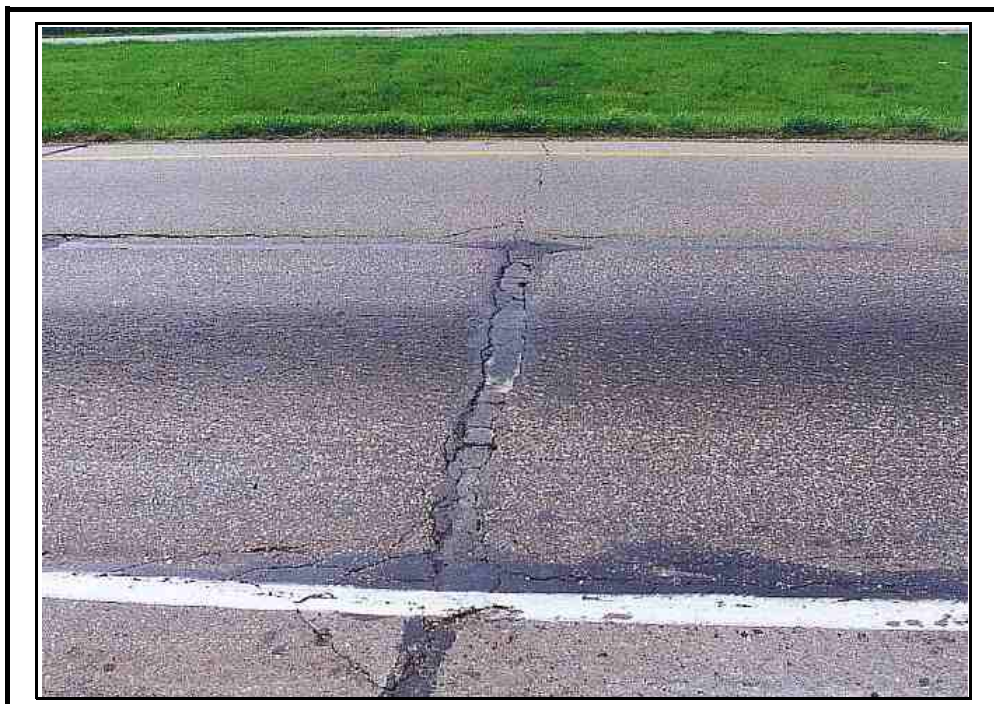
Photo B- 18. Jointed Base, Reflection Cracking in Composite Pavement, High Severity

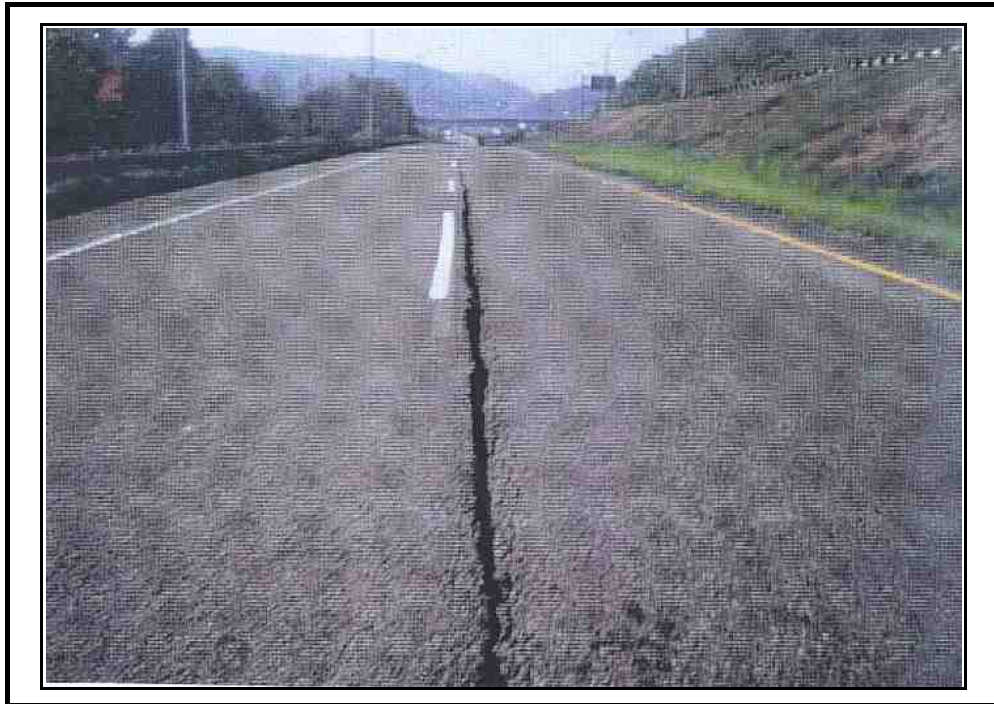
**Photo B- 19. Longitudinal Cracking in Composite Pavement,
High Severity**

Description: A crack or break approximately parallel to the pavement centerline. Longitudinal joints and pavement edges of underlying rigid base usually reflect through the asphalt surface as a result of thermal movement in the underlying slab. Poor paving lane joint construction can also result in a longitudinal crack. All types of longitudinal cracking (random, centerline, edge, etc.) are included in this distress classification for composite pavements.

High-- crack opened or spalled to a width greater than 25 mm (1 inch) over at least one half its length.

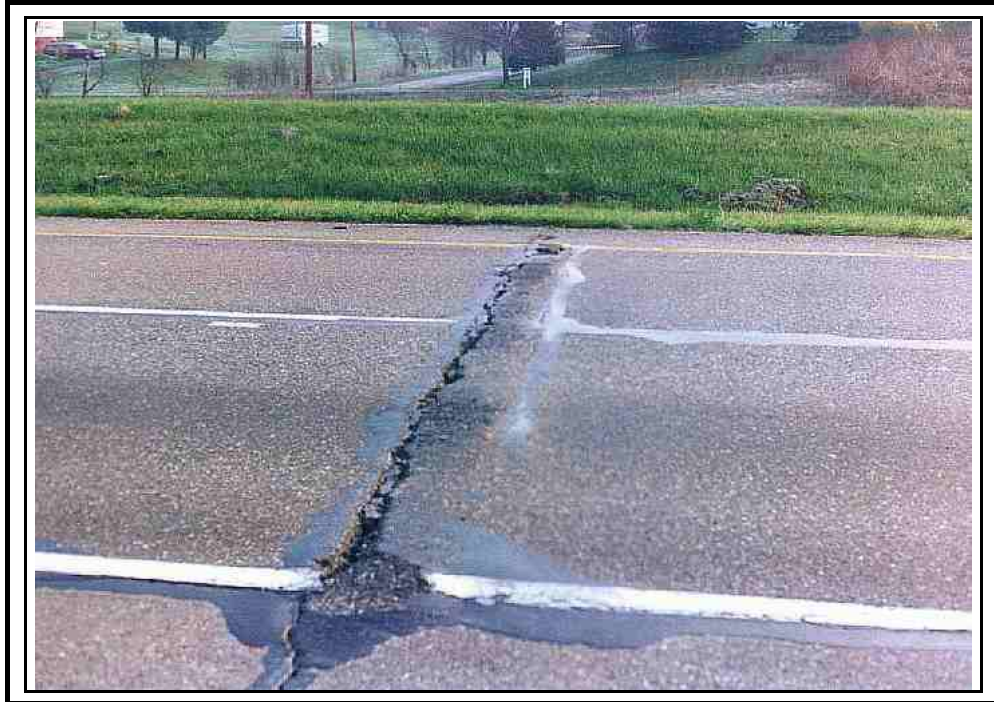
**Photo B- 20. Pressure Damage/Upheaval in Composite Pavement,
Medium Severity**

Distress Type:	Pressure Damage/Upheaval
Description:	Upheaval is a bump or hump in the pavement surface at a transverse joint or crack. The upheaval is a result of thermal expansion in the underlying concrete base creating compressive forces.
Severity Level:	Low-- bump height less than 13 mm ($\frac{1}{2}$ inch), barely noticeable effect upon ride. Medium-- bump height 13 to 25 mm ($\frac{1}{2}$ to 1 inch) with a readily noticeable effect upon ride quality. High-- bump height greater than 25 mm (1 inch) severely reducing ride quality.
Extent Level:	Occasional-- upheaval is present along less than 20 percent of the joints. Frequent-- upheaval occurs along 20 to 50 percent of the joints. Extensive-- greater than 50 percent of the joints exhibit upheaval.

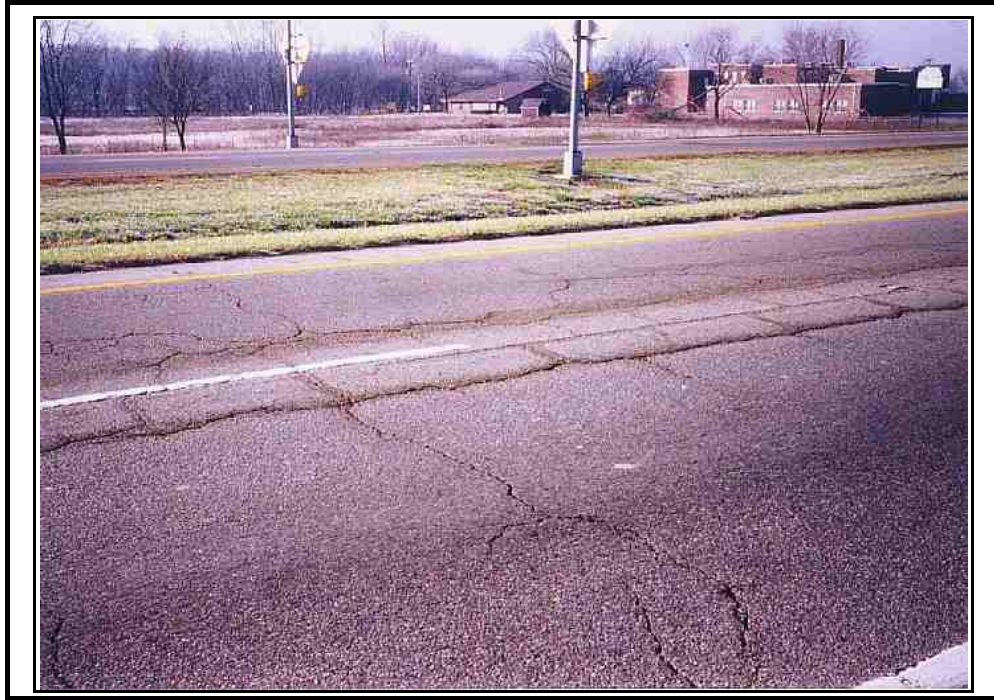
Photo B-21. Crack Sealing Deficiency, Unsealed Cracks

Description: Crack sealing deficiency is crack sealing which is no longer effective in preventing intrusion of water or cracks which have never been sealed.

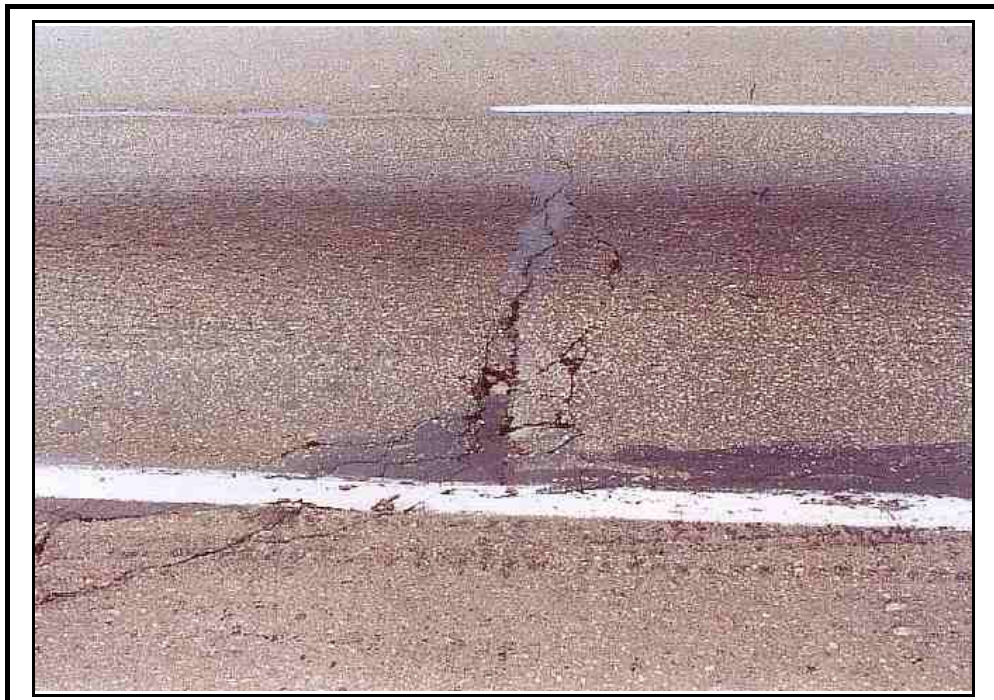
Photo B-22. Crack Sealing Deficiency, Cracks not sealed properly
